# McNeil Island Repair and Replacement Options 10182200022

Prepared by KPFF Consulting Engineers  
Draft Repair and Replacement Options  
June 30, 2022

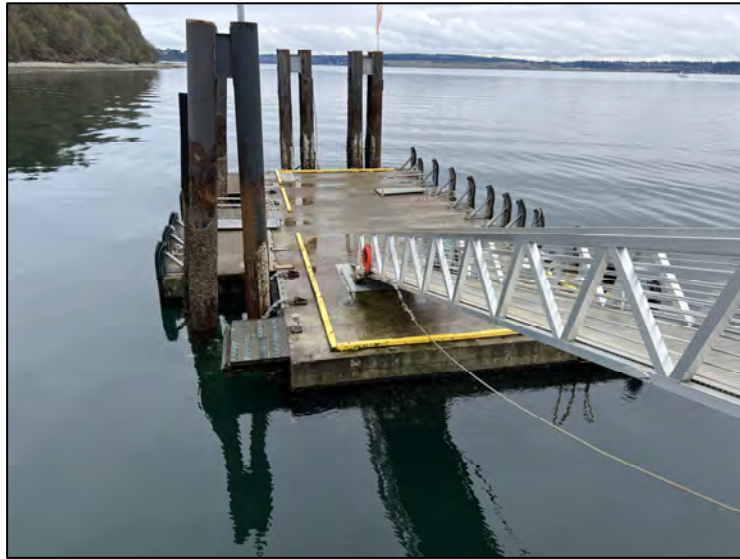
Photo 3: Island Mooring Float

Some of the significant deficiencies include damaged concrete on the floats, deteriorated piles, damaged rub strips on the piles, broken fenders and fender anchorage, damaged connections between floats, deterioration of the hinge at the upland end of the gangway, and deteriorated emergency ladder.

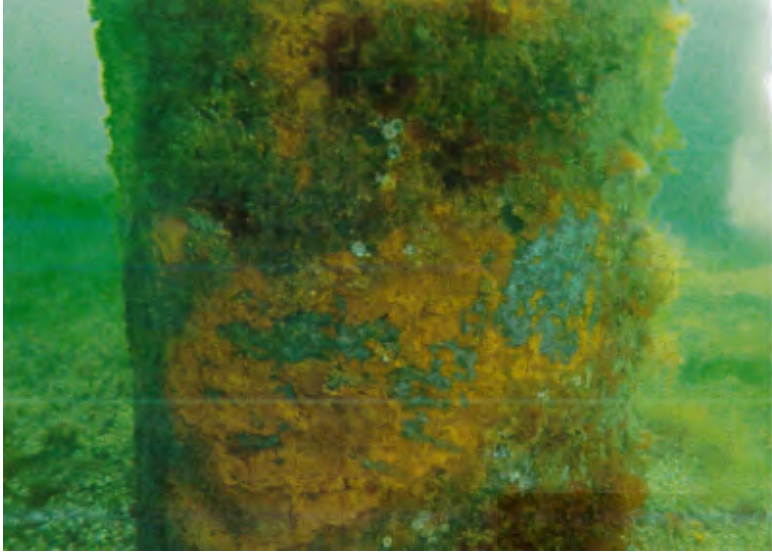
Photo 34: SP4 coating failure and surface corrosion

| SP4, Pile<br>C | SP4 | Delamination<br>and surface<br>corrosion | C2 | 25% coating<br>loss, UT<br>thickness<br>reading<br>0.390"/0.250" | Sandblast<br>and<br>recoat | P2 | 28 | 4 |

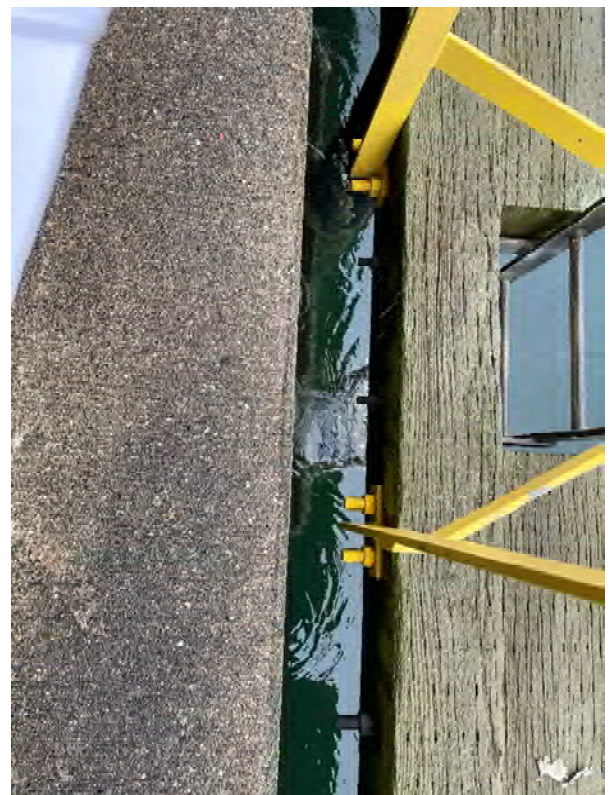
Photo 62: Pile F10 broken, South ladder is unsecured

**Minimum Repairs** – Repair trestle piles F10, D1, D2, D3, and D4. Patch concrete spalling, replace ladders, sandblast and coat mooring float piles, replace UHMW, sandblast and coat fenders, replace balcony loading platform, repair tie back cable attachment, and replace pile collar chain securement.

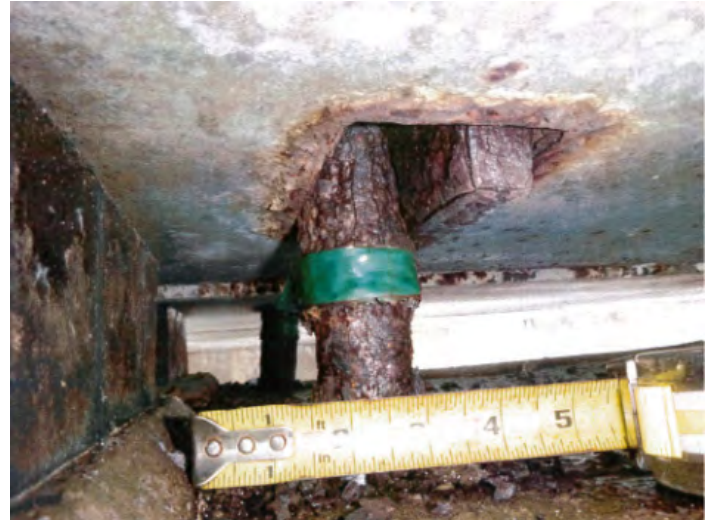
Photo 64: Deck panel 7B hold down bolt is necked down to 1.1875" at pier 7

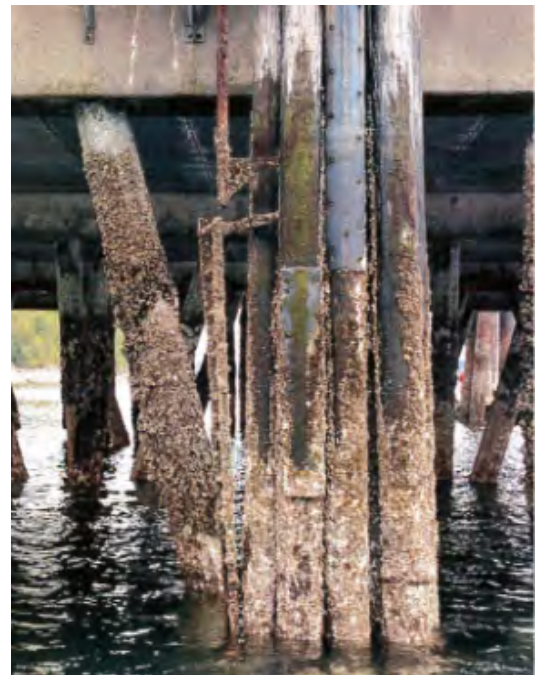
Photo 66: Dolphin D2 with abrasion damage, ladder detached

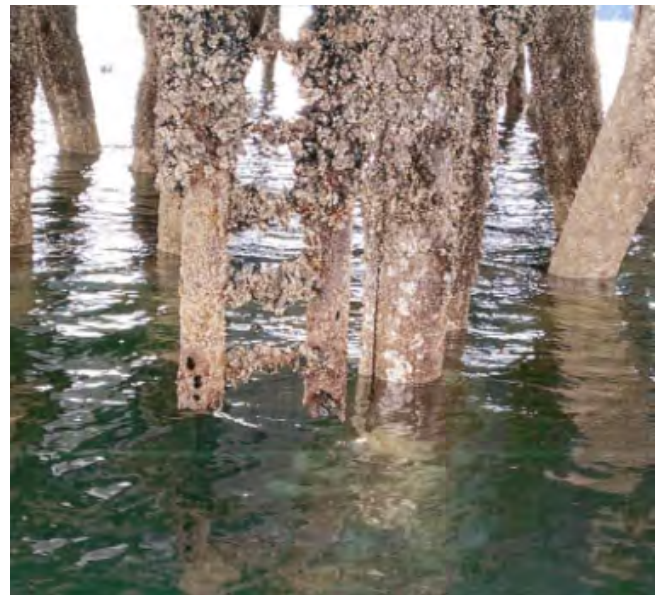
Photo 70: Boat lift access ladder has corroded off in lower intertidal zone.

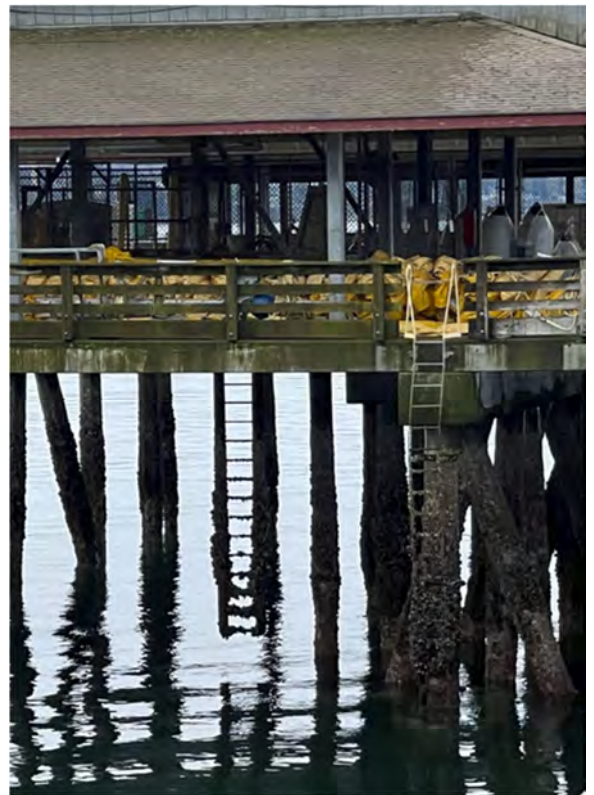
Photo 74: Northern and boat lift access ladders are in very poor condition

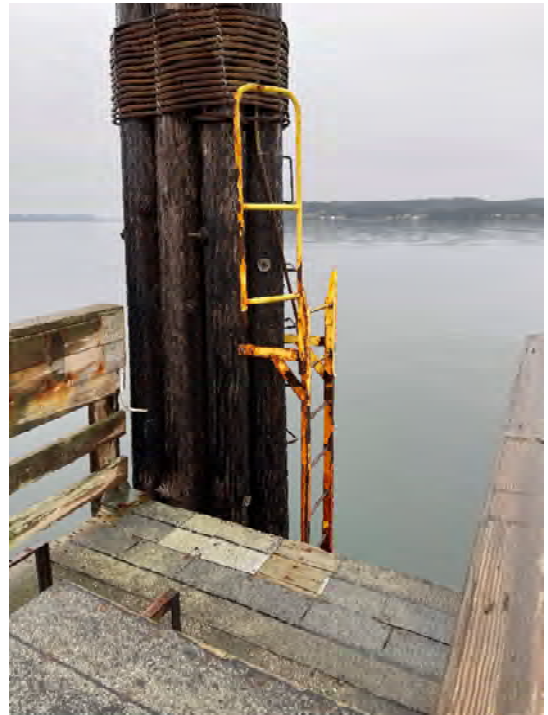
Photo 76: Dolphin ladder broken

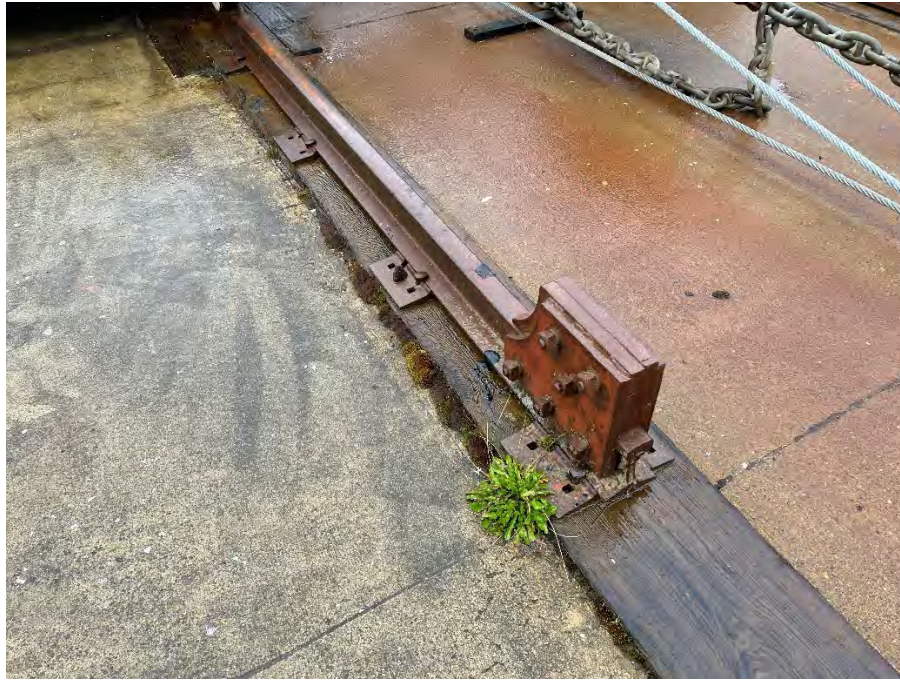
[Photo 126](#): Surface corrosion on rail North of bulkhead

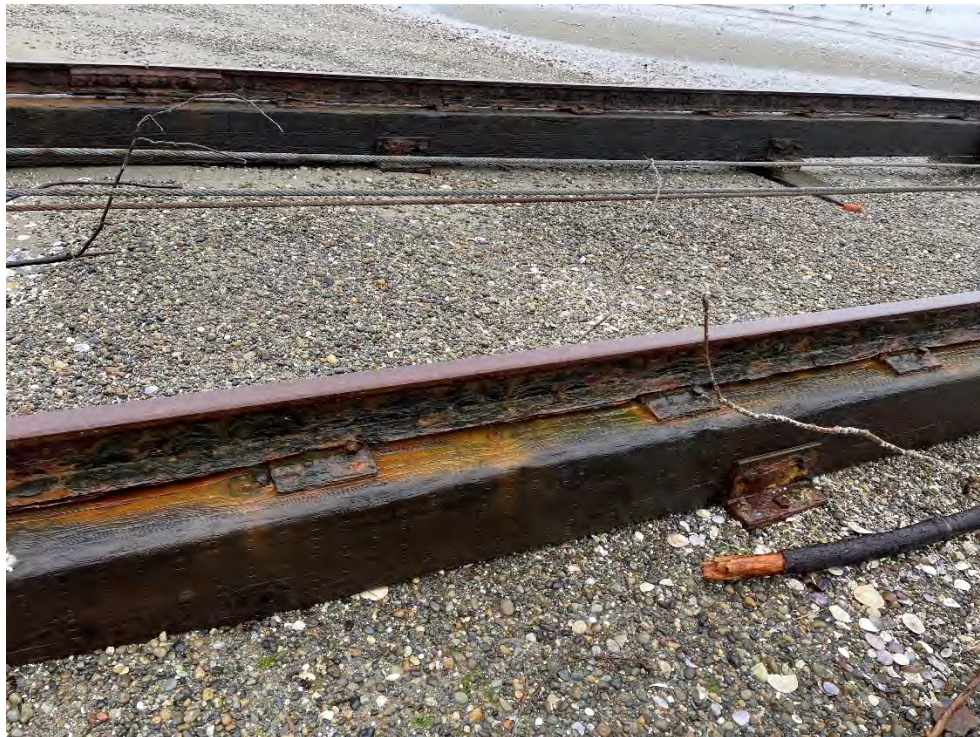
Photo 137: Heavy surface corrosion on rails and rail clips

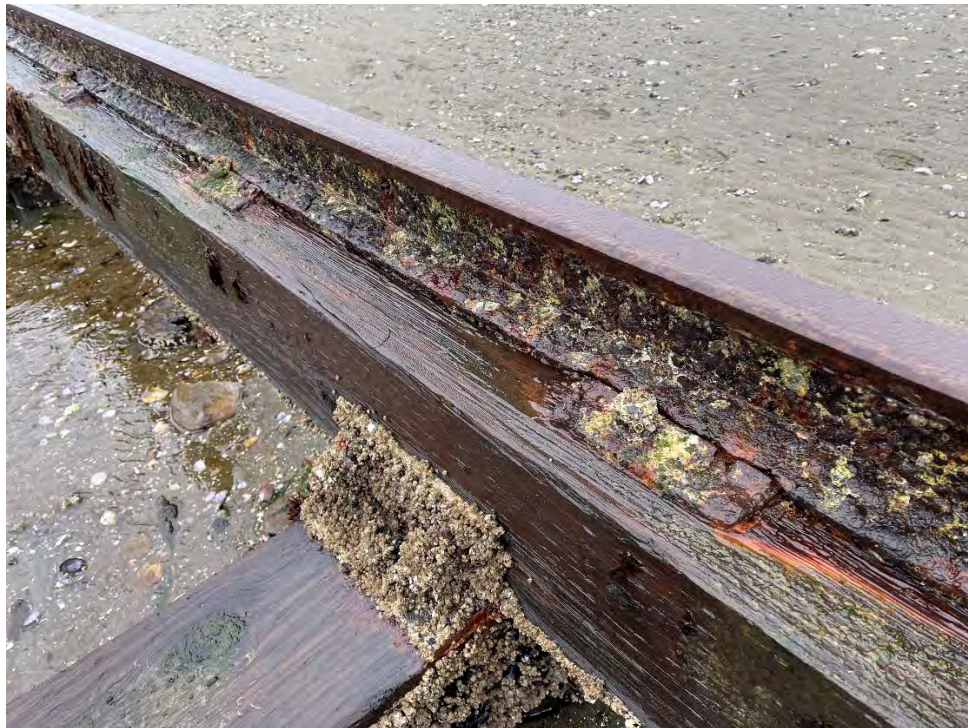
Photo 141: Heavy surface corrosion on rail and pile cap connection bracket

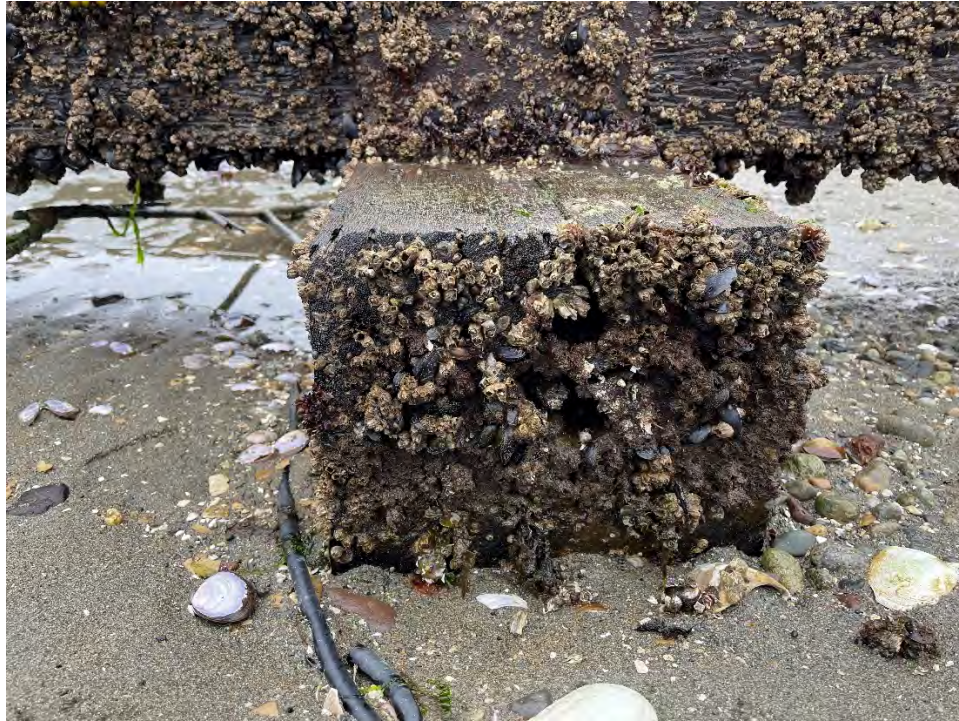
| 15 | C3 | P3 | Hollowing/rotting | The pile cap should no longer be in service due to the loss of strength from degradation of material. | 142 | 6 |

Photo 142: 15<sup>th</sup> pile cap with early stages of hollowing
