# McNeil Island Repair and Replacement Options 10182200022

Prepared by KPFF Consulting Engineers  
Draft Repair and Replacement Options  
June 30, 2022

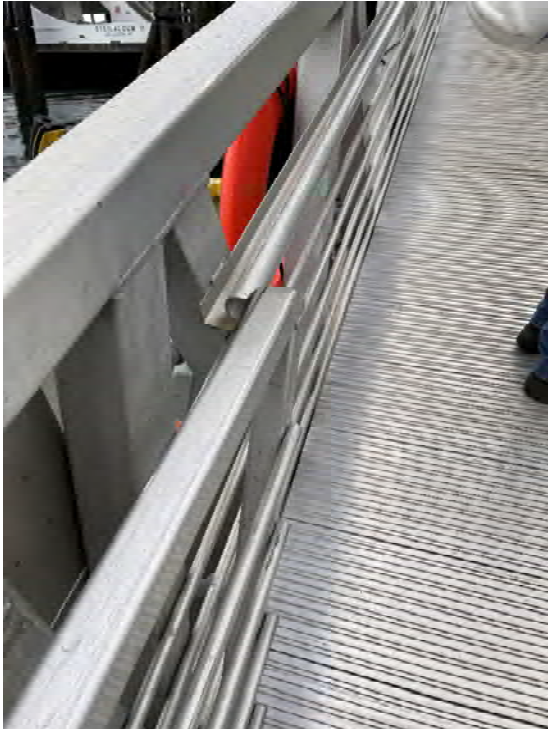
Photo 21: Loading ramp handrail with sharp edge

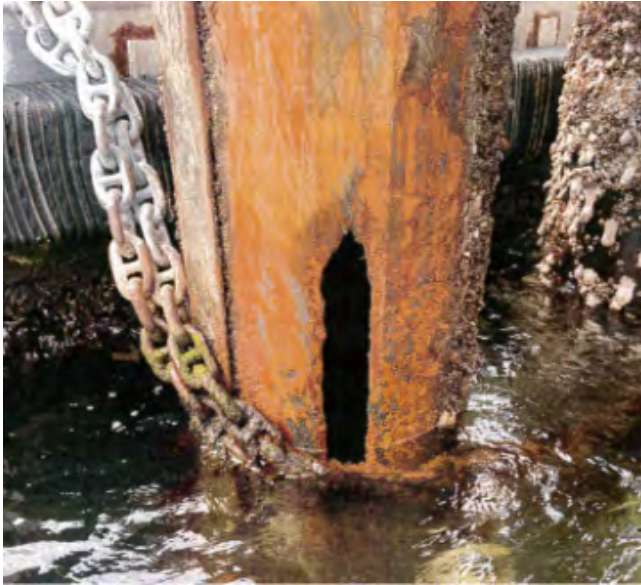
Photo 39: SP4-A holed through

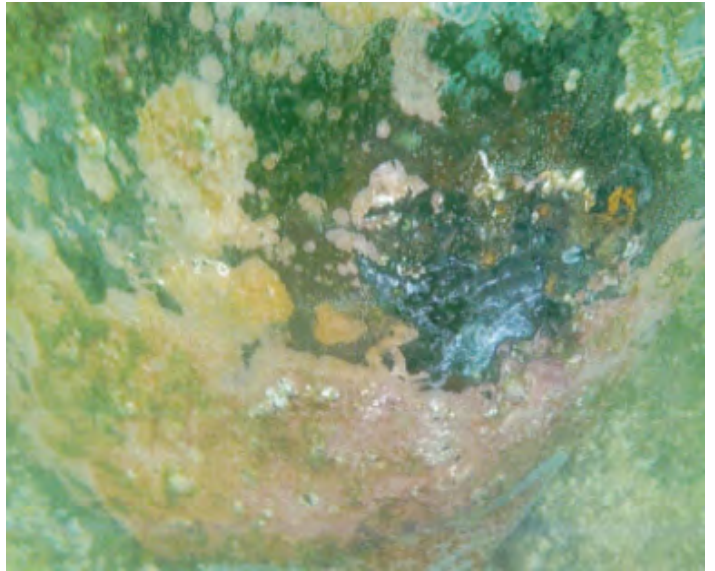
Photo 40: SP4-B deep pitting

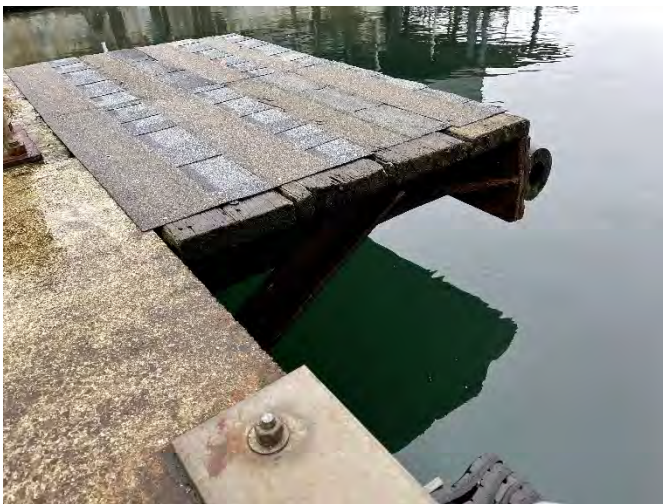
Photo 61: Balcony loading platform

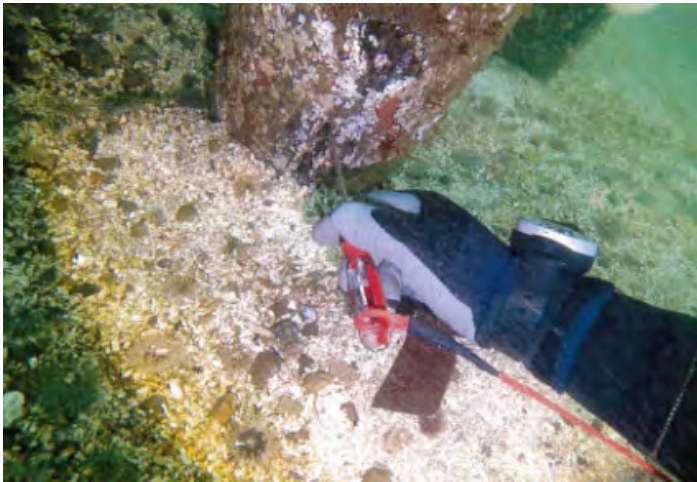
Photo 93: Right wingwall, pile 31 with MBE
