# McNeil Island Repair and Replacement Options 10182200022

Prepared by KPFF Consulting Engineers  
Draft Repair and Replacement Options  
June 30, 2022

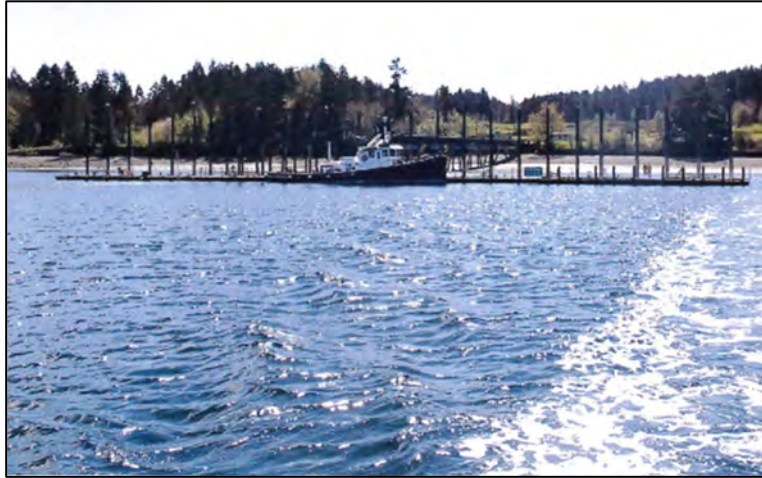
Photo 6: Still Harbor Dock

The Still Harbor Dock is used as the backup ferry landing as well as the primary dock for the emergency vessel and other vessels and barges that are out of service. The dock consists of concrete floats arranged in a T which are held in place by steel guide piles. The floats are accessed by a hinged aluminum gangway supported at the end of a concrete trestle. The trestle is supported by concrete piles. The only issue known at this time is that the steel guide piles have deteriorated.

See Appendix D for a photo example of each type of damage listed. KPFF recommends replacing the existing steel piles with new piles.

Minimum Repairs – Replace all poorly rated piles.

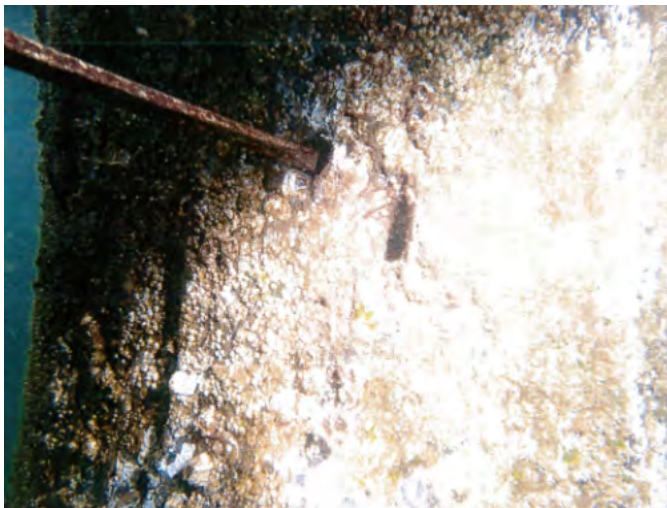
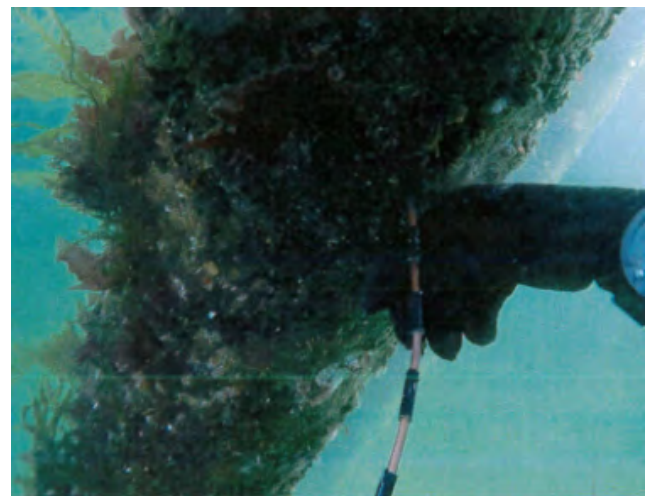
Photo 14: Pile 9B 3 marine borer entry (MBE) holes

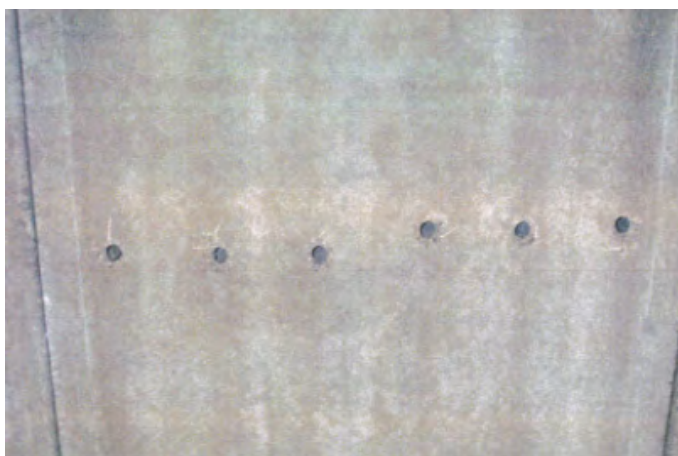
Photo 15: Pile F7 marine borer entry (MBE)

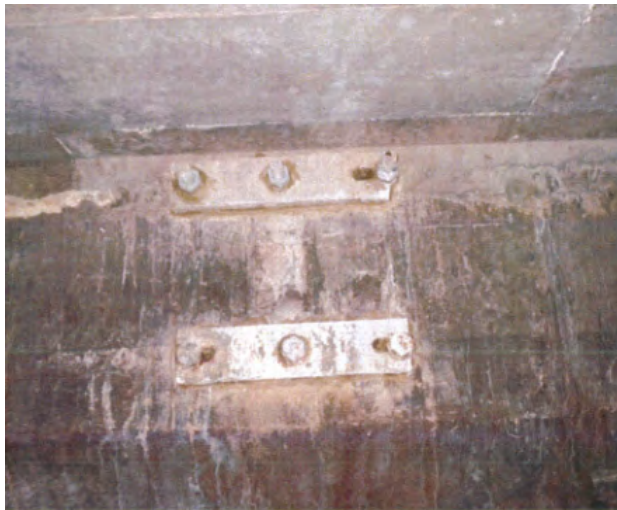
Photo 31: Cell #8 pile collar connections

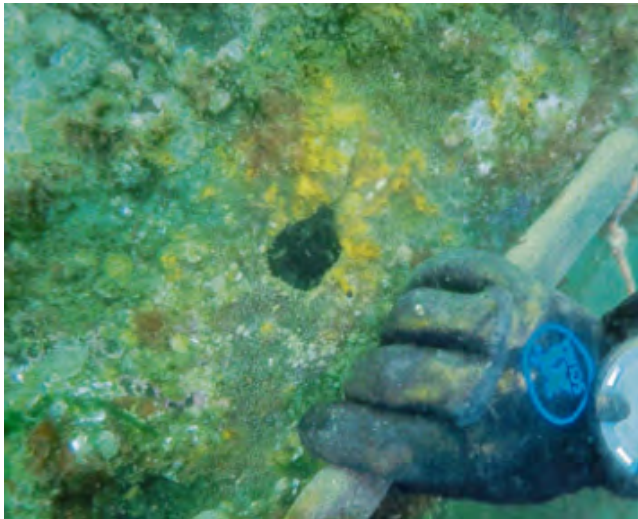
Photo 37: SP3-B holed through

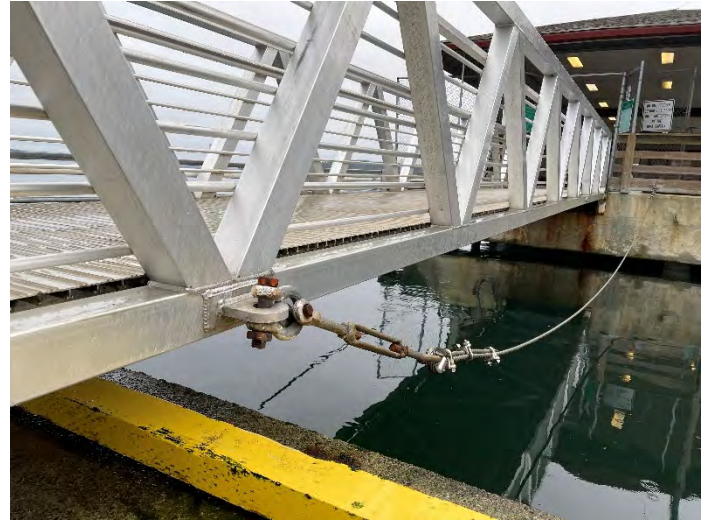
Photo 44: Tie back cable attachment

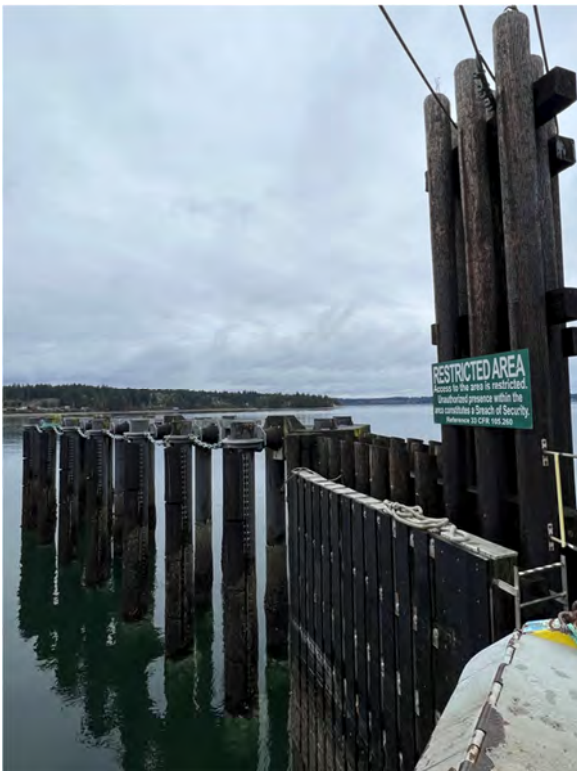
Photo 87: Right wingwall

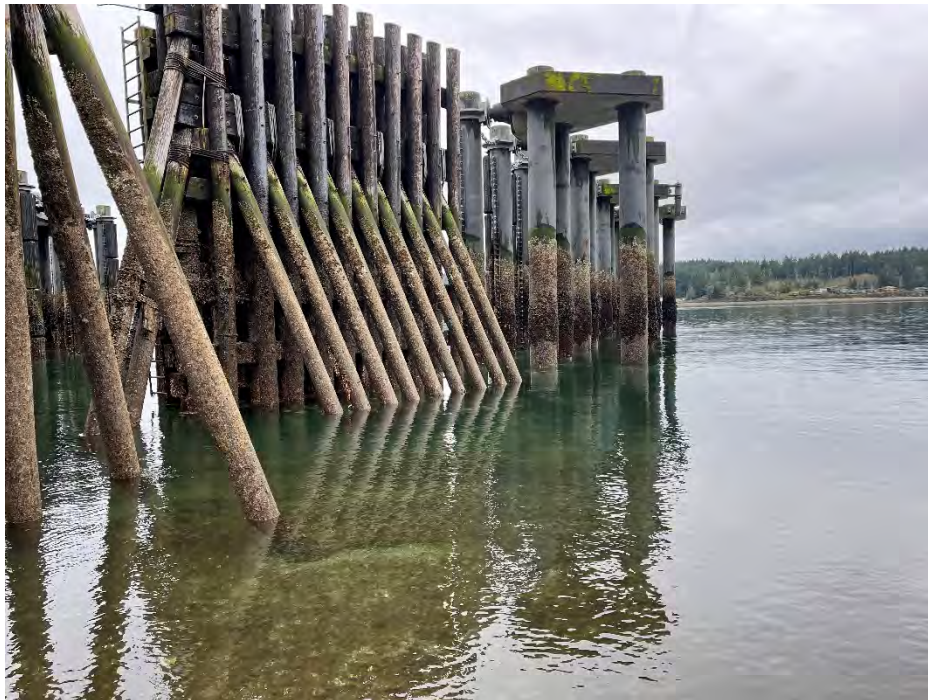
Photo 90: Right wingwall

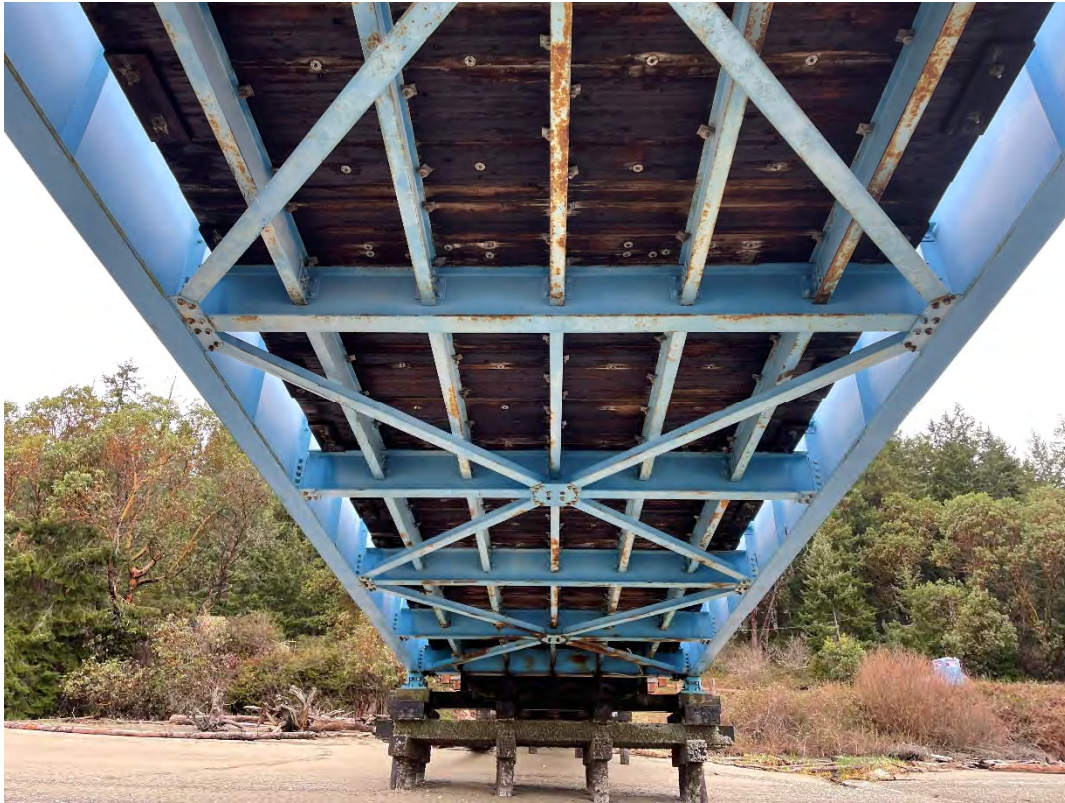
Photo 96: Beneath the trestle

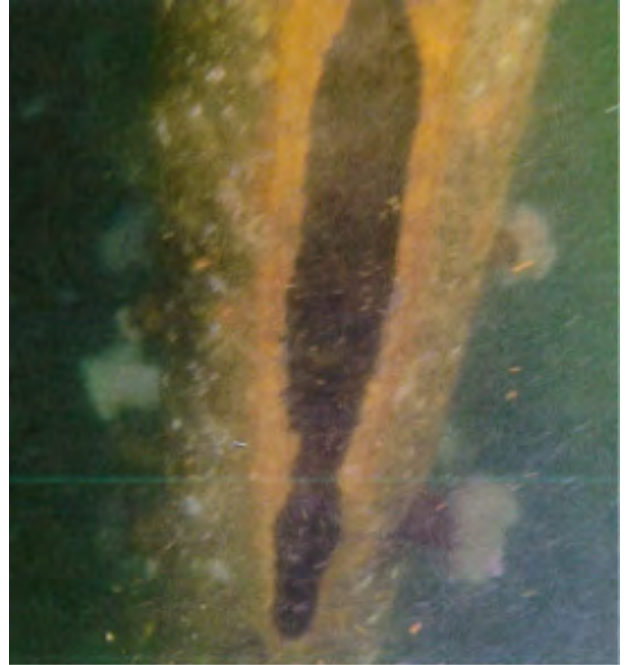
Photo 114: Pile D, 4" W x 36" H  
hole from mechanical abrasion

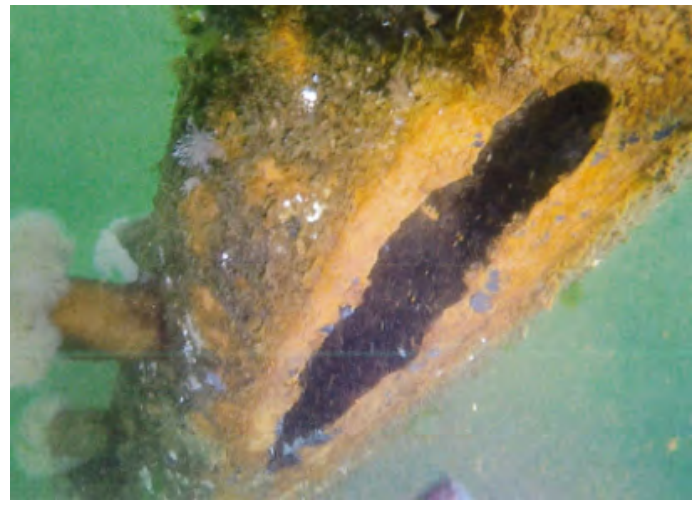
Photo 119: Pile L, 3" W x 24" H hole from mechanical abrasion

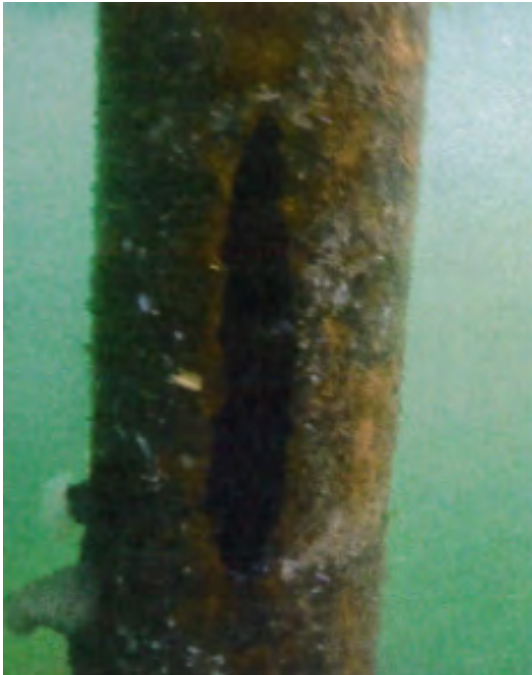
Photo 120: Pile O, 4" W x 24" H hole from mechanical abrasion

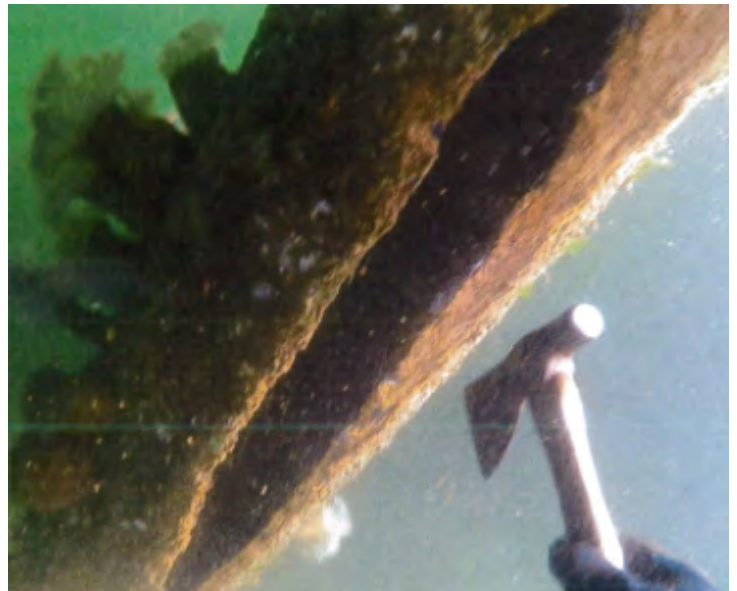
Photo 121: Pile P, 5" W x 54" H hole from mechanical abrasion

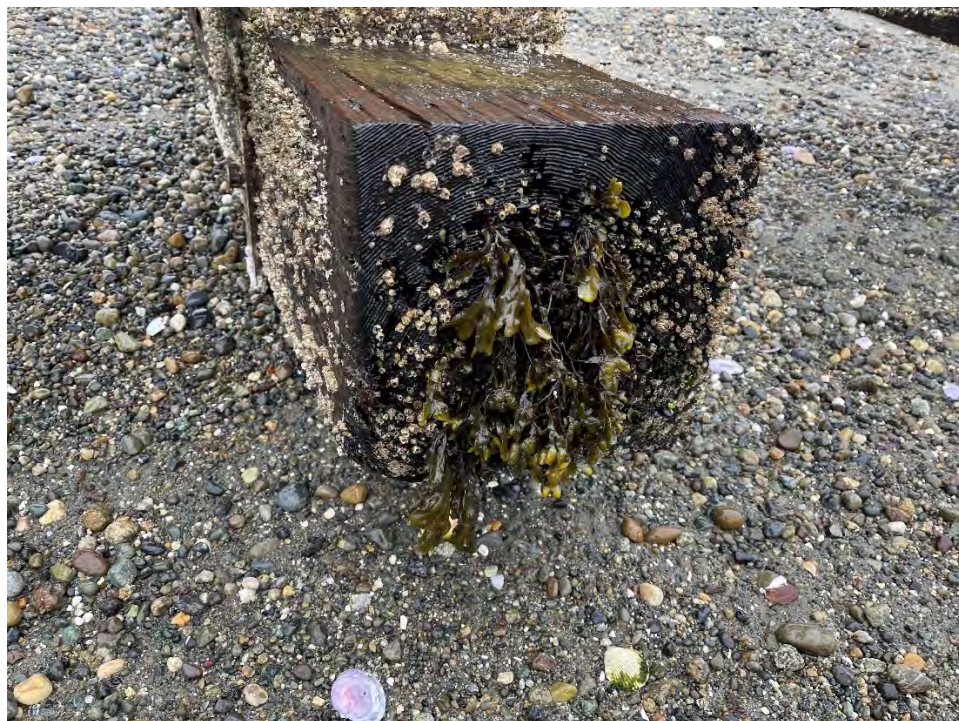
Photo 143: 17<sup>th</sup> pile cap with early stages of hollowing

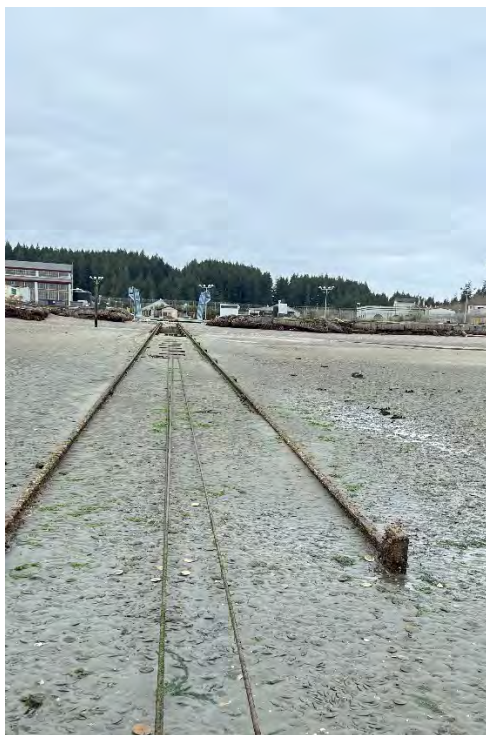
Photo 171: Buried members on Southern section of rail system

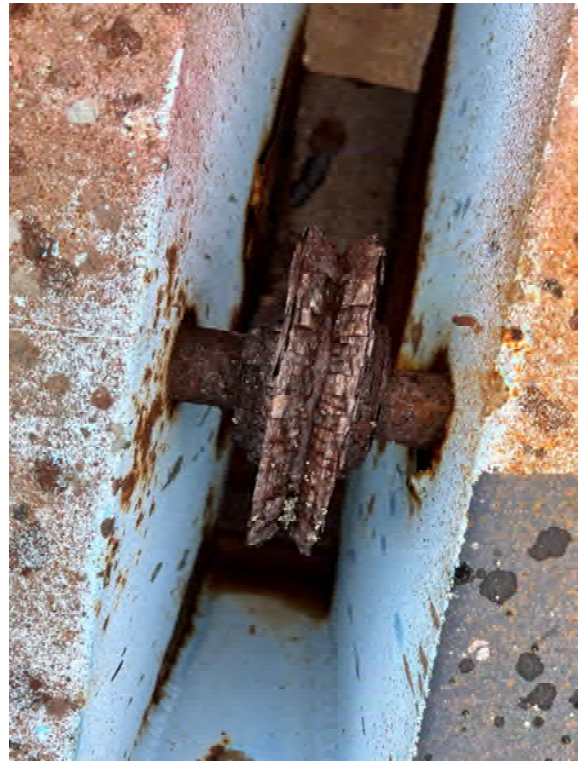
Photo 191: Bilge block pulley

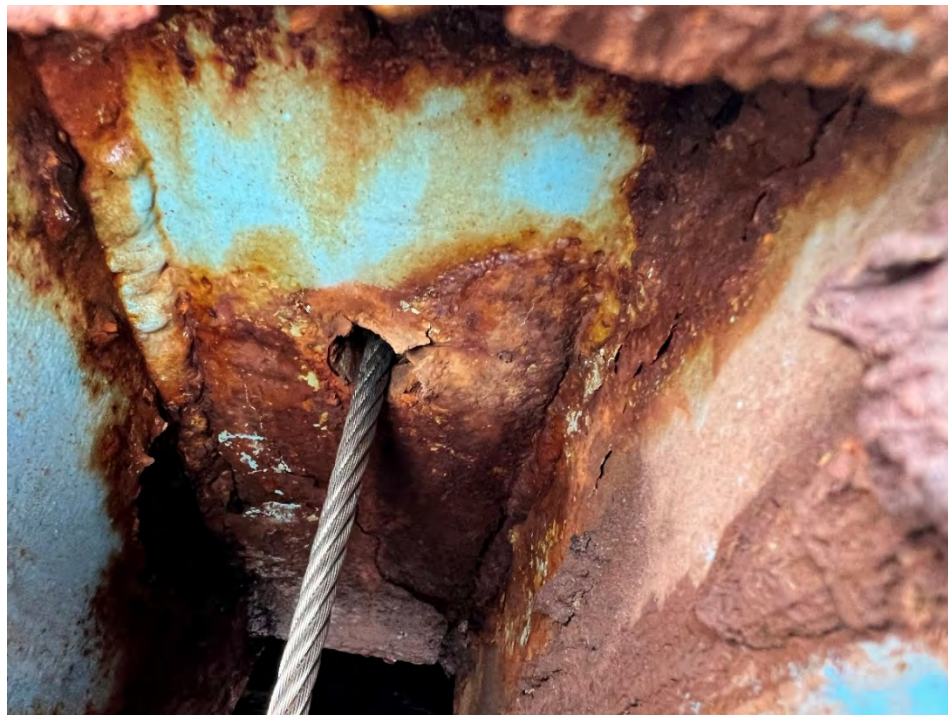
Photo 192: Bilge block pulley
